**Flood Control Project Maintenance
Levee Inspections**
LMA District Cover Sheet
Spring 2017 Levee Inspection Results

Merced Streams Group

**Flood Control Project Maintenance
Levee Inspections
Unit Cover Sheet
Spring 2017 Levee Inspection Results
Merced Streams Group**

| Waterway | | | Bank | Unit Miles |
|--|---|---|---|---|
| Unit No. 01 Black Rascal Diversion | | | Right | 1.61 |

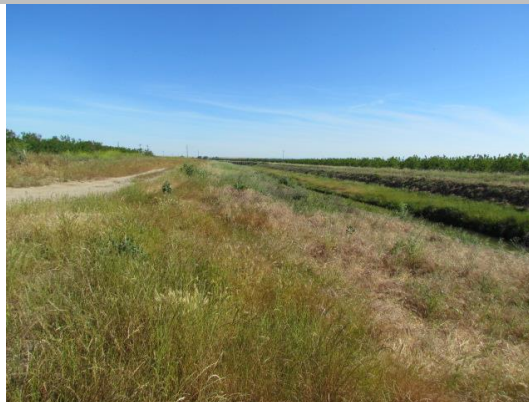
Photo 1 of 1 : SP_2017_NA0013_331_8_20170502_00004.jpg

Standing on the waterside slope looking upstream at the unsatisfactory tall weed growth.

| Spray or mow the tall weeds from the waterside levee slope. | | | | | |

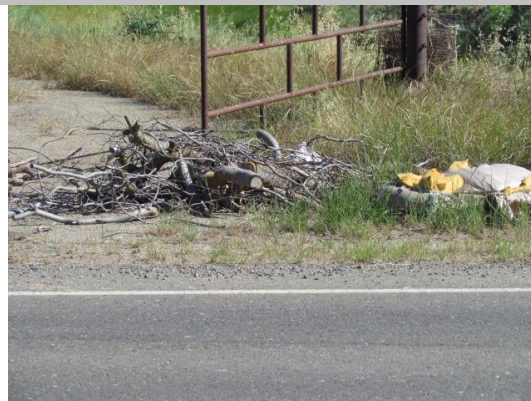
Photo 1 of 1 : SP_2017_NA0013_331_9_20170502_00007.jpg

Unwanted garbage dumped on the waterside shoulder.

| Remove the garbage from the waterside shoulder. | | | | | |

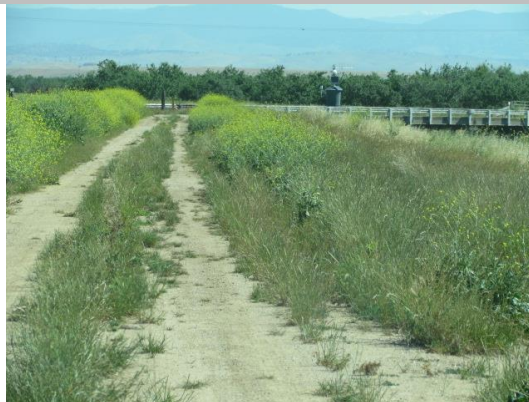
Photo 1 of 1 : SP_2017_NA0013_331_13_20170502_00010.jpg

Looking back upstream from levee mile 1.05-1.61 unwanted weeds present on the crown roadway.

| Remove the unwanted debre from the crown roadway. | | | | | |

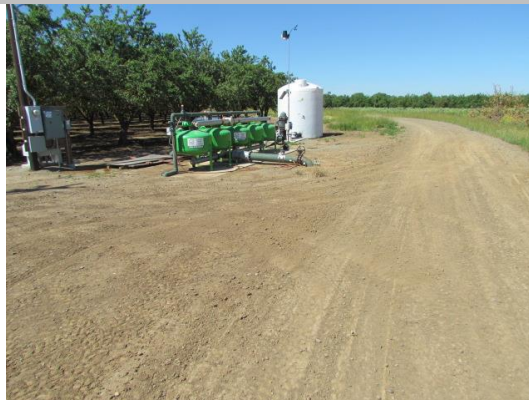
Photo 3 of 3 : SP_2017_NA0013_332_2_20170502_00032.jpg

No Permit for this filtration system and tank on the easement. No change since last inspection.

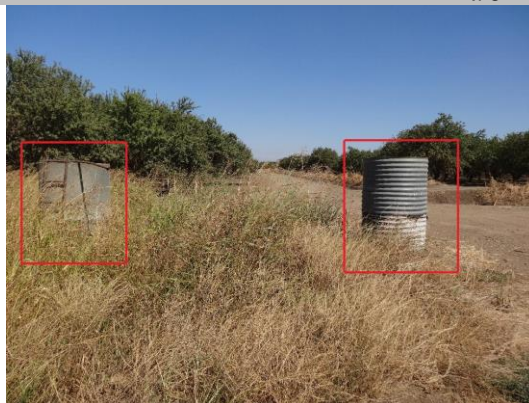
Photo 1 of 3 : UCIP_SP_2017_21263_35761.jpg

| FS_ID:21263 DS_ID:23052 EP_NO: N/A Repair Type: Non-Urgent Crossing Status: Found UCIP Comments: - needs more investigations on this crossing. - new water filtration plant on LS with pump and concrete vault.- a concrete standpipe and CM pipe riser on WS. FIELD_STRUCT_DESC: 10-inch steel pipe through the levee, 5.0 feet below the crown, riser on the landward side, screw gate in a 36-inch pipe well on the waterward slope (O&M Unit No. 607, 1962) FS Date: 9/17/2013 | | | | | |

WS view: concrete standpipe (left) and CMP standpipe (right).

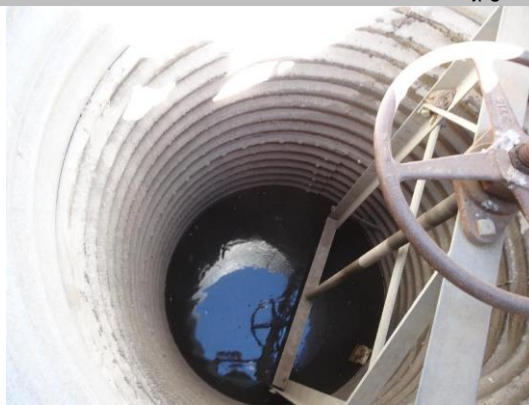
Photo 2 of 3 : UCIP_SP_2017_21263_35760.jpg

WS view: inside view of CMP standpipe with slide gate.

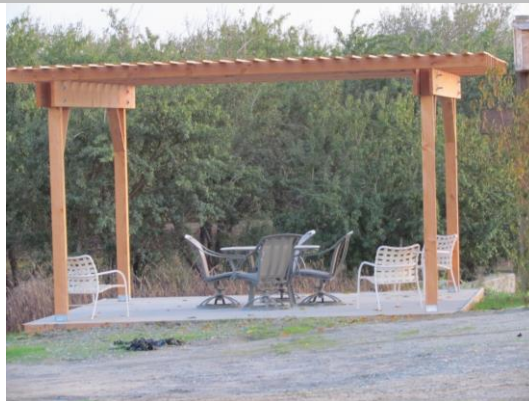
Photo 1 of 4 : SP_2017_NA0013_332_24_20170404_00004.jpg

| Three fruit trees with irrigation system, stock pile of material (2) piles on the land side toe and rock pad placed on land side toe. Discovered during the fall 2014 inspection a structure has been installed on the landward levee slope and berm. No permit for these encroachments. | | | | | |

Unauthorized encroachment placed on the landside shoulder and berm.

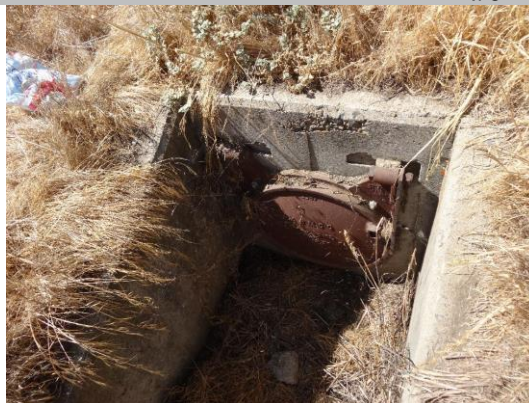
Photo 1 of 3 : UCIP_SP_2017_41815_35533.jpg

| FS_ID:41815 DS_ID:23060 EP_NO: N/A Repair Type: Non-Urgent Crossing Status: Found UCIP Comments: - more than a half of inet pipe burried on LS. - needs vegetation cleaning on both sides.- inlet needs silt removed and cleaning. FIELD_STRUCT_DESC: 24-inch corrugated metal drainage pipe through the levee, 6.0 feet below the crown, concrete headwall, flap gate, and concrete grouted cobble spillway on the waterward toe, concrete headwall on the landward toe (O&M Unit No. 607, 1962) FS Date: 9/17/2013 | | | | | |

WS view: U typed concrete headwall, CM pipe, and flap gate.

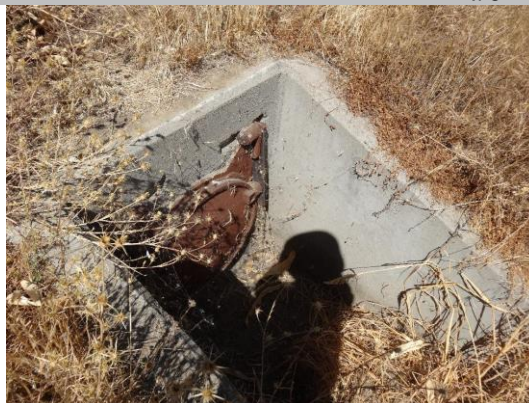
Photo 2 of 3 : UCIP_SP_2017_50151_35538.jpg

WS view: U typed concrete headwall, CM pipe, and flap gate. Vegetation needs to be cleared.

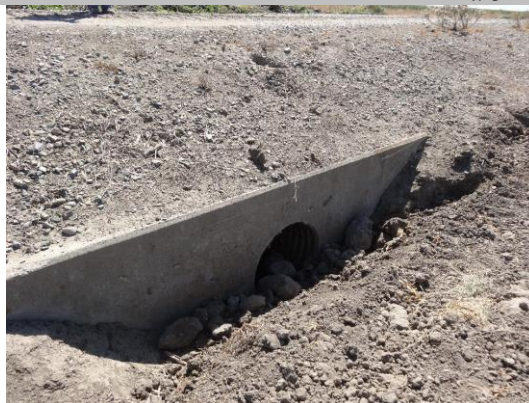
Photo 2 of 3 : UCIP_SP_2017_21063_35501.jpg

LS view: concrete headwall and CM pipe. Inlet needs clearing.

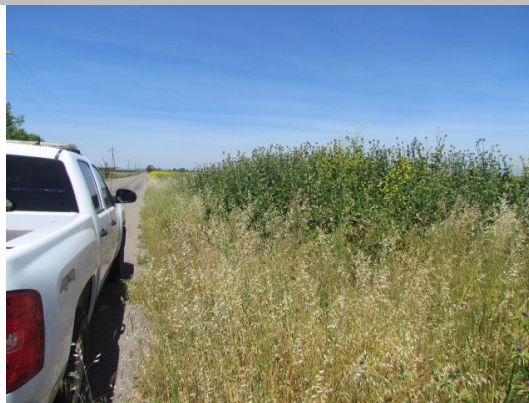
Photo 1 of 1 : SP_2017_NA0013_334_11_20170519_00028.jpg

Owens Creek Unit 4 looking upstream the unsatisfactory wild weed growth has completely block the view of the levee section.

| Remove the wild growth other than native grasses from the levee slope and berm. | | | | | |

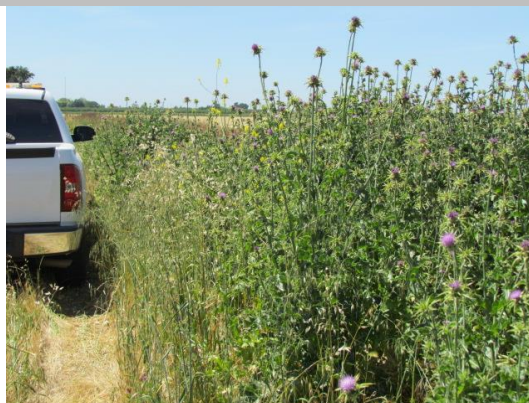
Photo 1 of 1 : SP_2017_NA0013_334_12_20170519_00029.jpg

Owens Creek Unit 4 looking at the waterside levee sloped downstream.

| Remove the wild growth other than native grasses from the levee section. | | | | | |

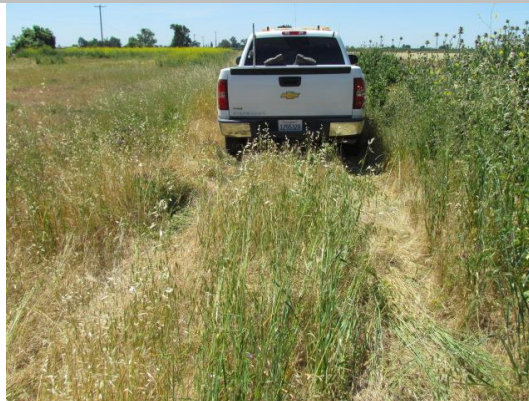
Photo 1 of 2 : SP_2017_NA0013_334_13_20170519_00030.jpg

Owens Creek Unit 4 levee mile 0.04 looking downstream towards levee mile 1.41 the wild weeds has completely covered the levee crown roadway.

| The crown roadway must be free of vegetation. | | | | | |

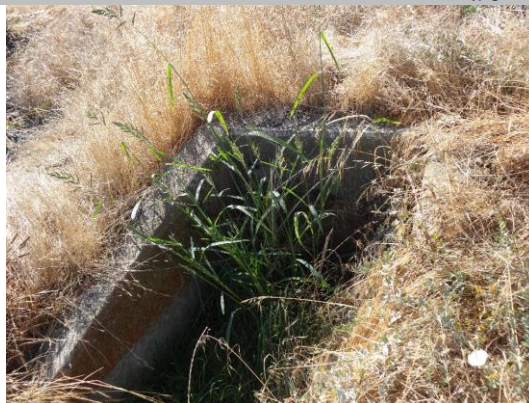
Photo 1 of 3 : UCIP_SP_2017_42991_35751.jpg

WS view: concrete spillway and channel on waterside. Dense vegetation on levee slope and spillway.

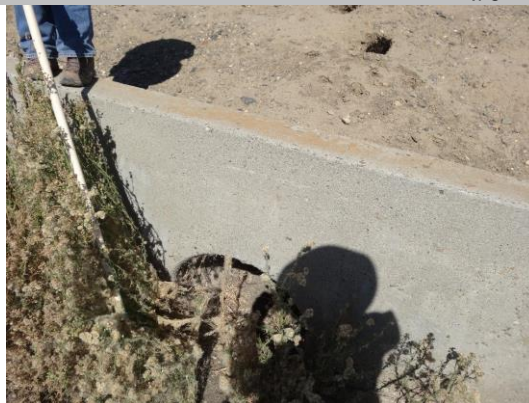
Photo 2 of 3 : UCIP_SP_2017_50146_35747.jpg

LS view: concrete headwall and CM pipe. Inlet needs clearing.

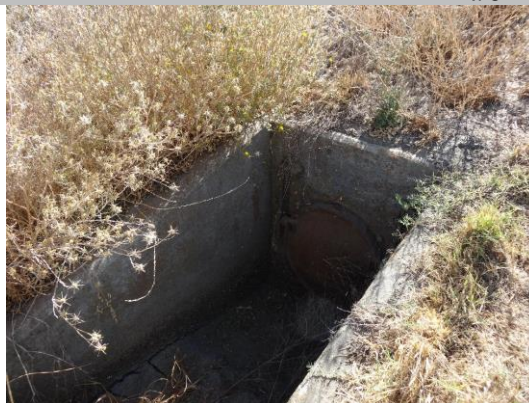
Photo 2 of 3 : UCIP_SP_2017_50154_35607.jpg

WS view: U typed concrete headwall, CM pipe, and flap gate. Vegetation needs to be cleared on spillway.

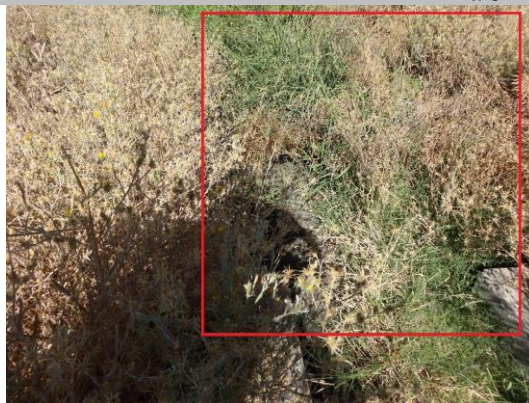
Photo 1 of 3 : UCIP_SP_2017_50148_35613.jpg

WS view: Dense vegetation on levee slope and spillway.

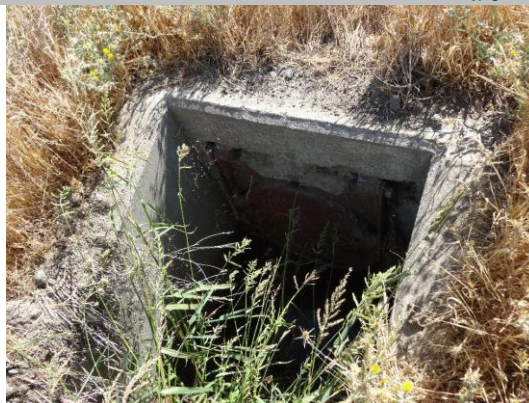
Photo 2 of 3 : UCIP_SP_2017_50155_35641.jpg

WS view: U typed concrete headwall, CM pipe, and flap gate. Vegetation needs to be cleared.

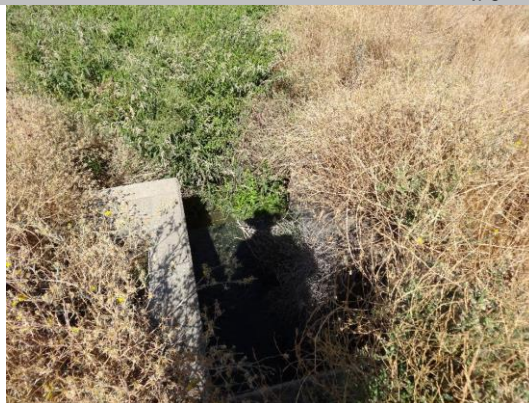
Photo 1 of 3 : UCIP_SP_2017_21126_35652.jpg

WS view: concrete spillway and channel on waterside. Dense vegetation on levee slope and spillway.

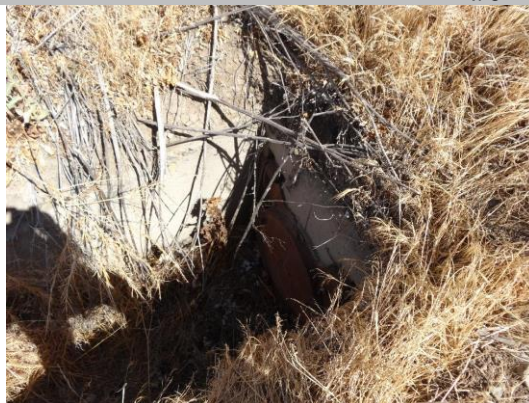
Photo 1 of 3 : UCIP_SP_2017_21210_35709.jpg

WS view: concrete spillway and channel on waterside. Dense vegetation on levee slope and spillway.

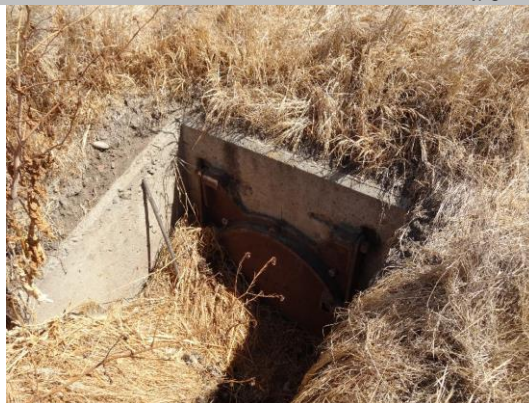
Photo 1 of 3 : UCIP_SP_2017_50153_35745.jpg

WS view: U typed concrete headwall, CM pipe, and flap gate. Dirt and vegetations need to be removed and cleared.
